AN ENGINEERED RESERVE FUND STUDY

By Clear Path Engineering Inc.

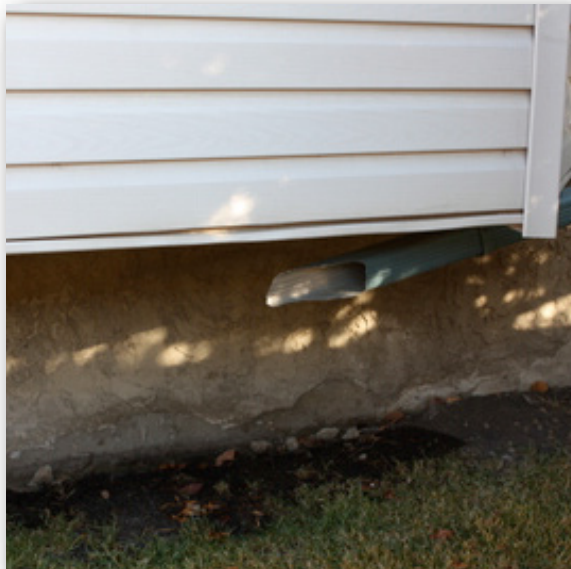
3.1 Downspouts located too close to the foundation of the building.

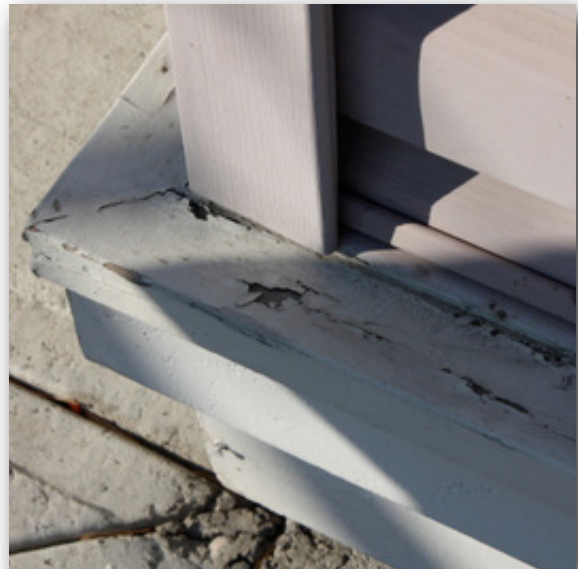
3.2 Extensive peeling of paint on wood trim.

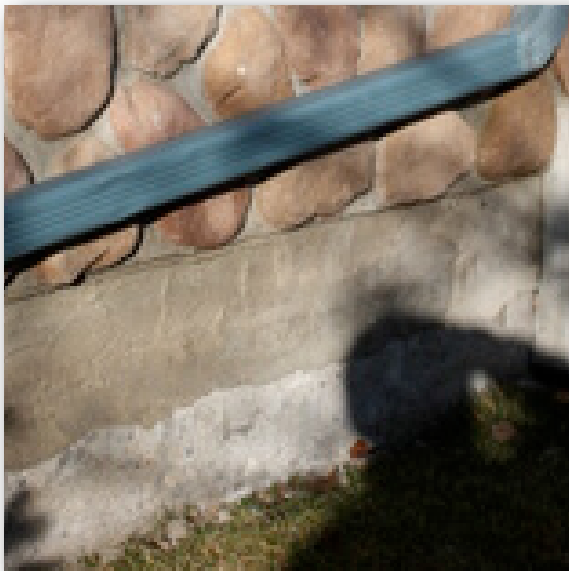
3.3 Parging break offs.

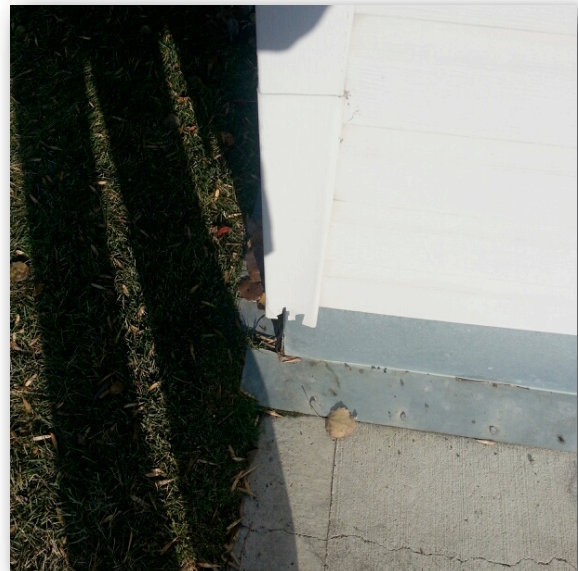
3.4 Minor damage to the vinyl siding on the north refuse building.

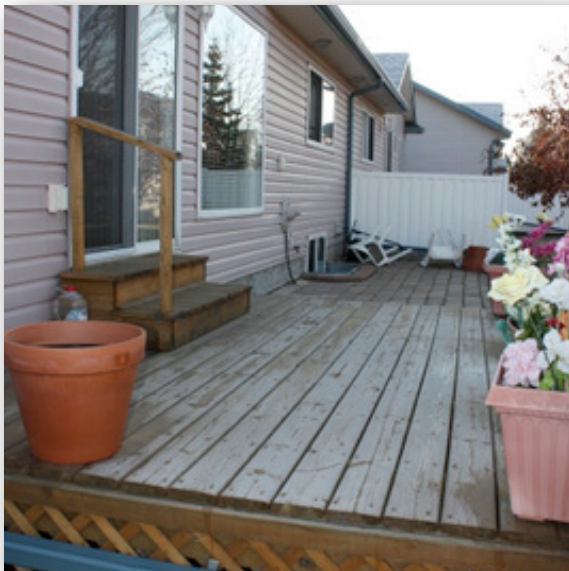
3.5 Balcony decks are worn and are in need of staining.

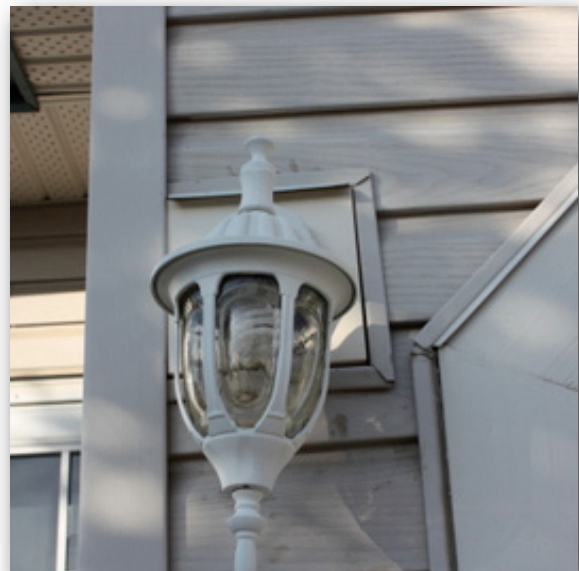
3.6 Standard exterior light fixtures.

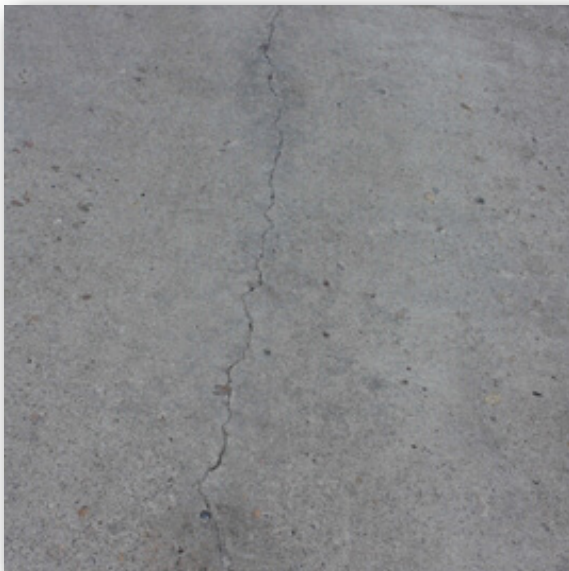
3.7 Some cracking in concrete driveway aprons.

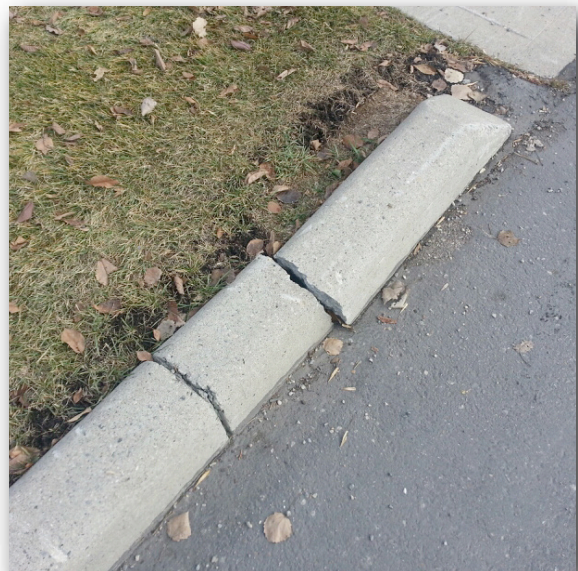
3.8 Break offs to the cast in place concrete curbs.

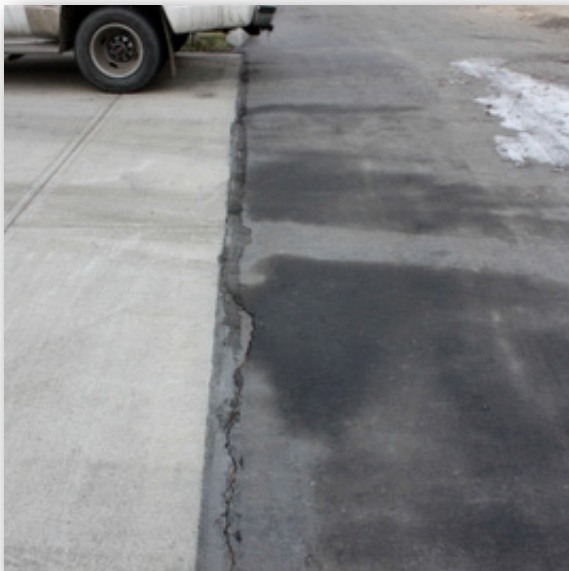
3.9 The joint between driveways and pavement is in need of new sealant.

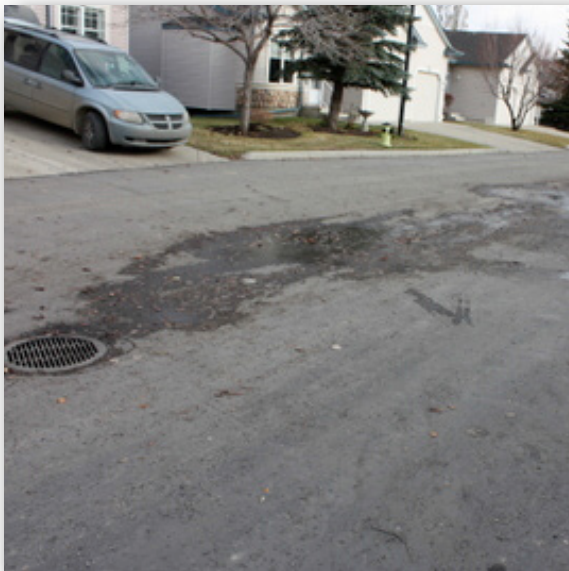
3.11 Settled area in the asphalt pavement resulting in poor drainage.
